CENTMAX ENGINEERING TECHNOLOGY SOLUTIONS

LABORATORY AND FIELD TESTING OF FOUNDATIONS SERVICES

JOINT VENTURE OF PYRAMID TECHNICAL SERVICES AND CENTMAX ENGINEERING AND TECHNOLOGY SOLUTIONS
CETS

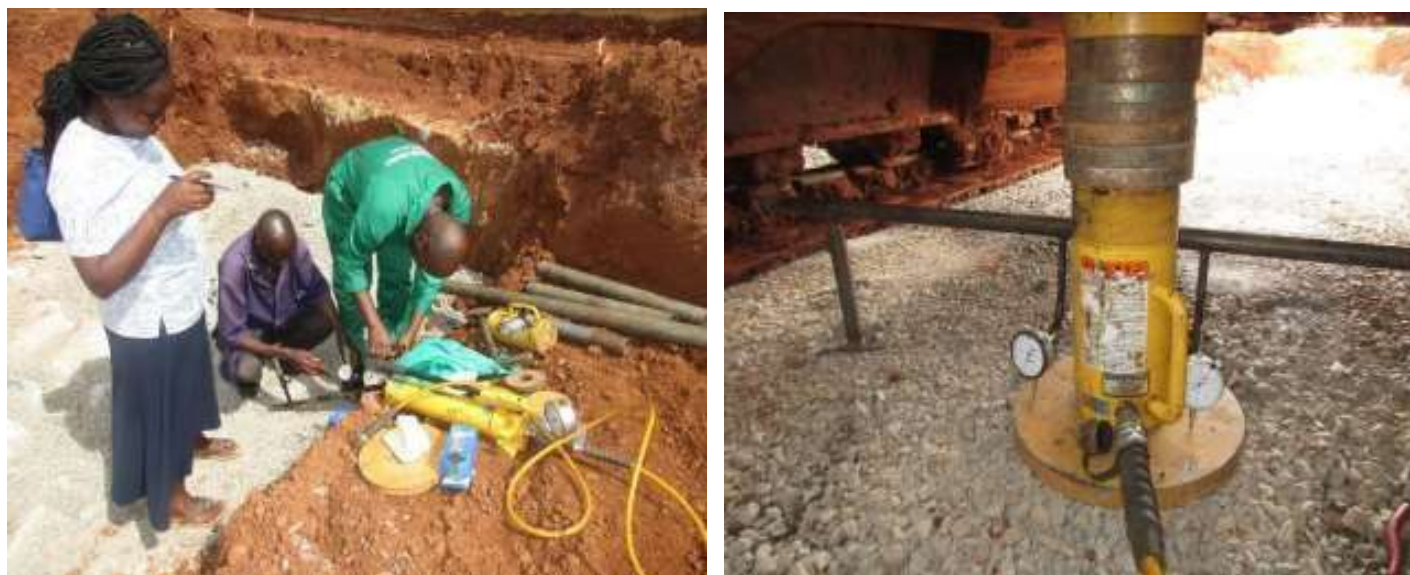
Plates 2&3: The plate load equipment

The field exploratory activities are conducted in accordance with ASTM D1195 – 93 and BS1377, Part 9, (1990) Clause 4.1 "Determination of the vertical deformation and strength characteristics of soil by the plate loading test" Steel bearing plate assembly was placed on the existing ground which had been cleared of debris and thereafter a 10-ton loaded truck or an excavator was conveniently positioned to provide the necessary dead load to the equipment. Subsequent live loads are gradually increased by means of a hydraulic jack.

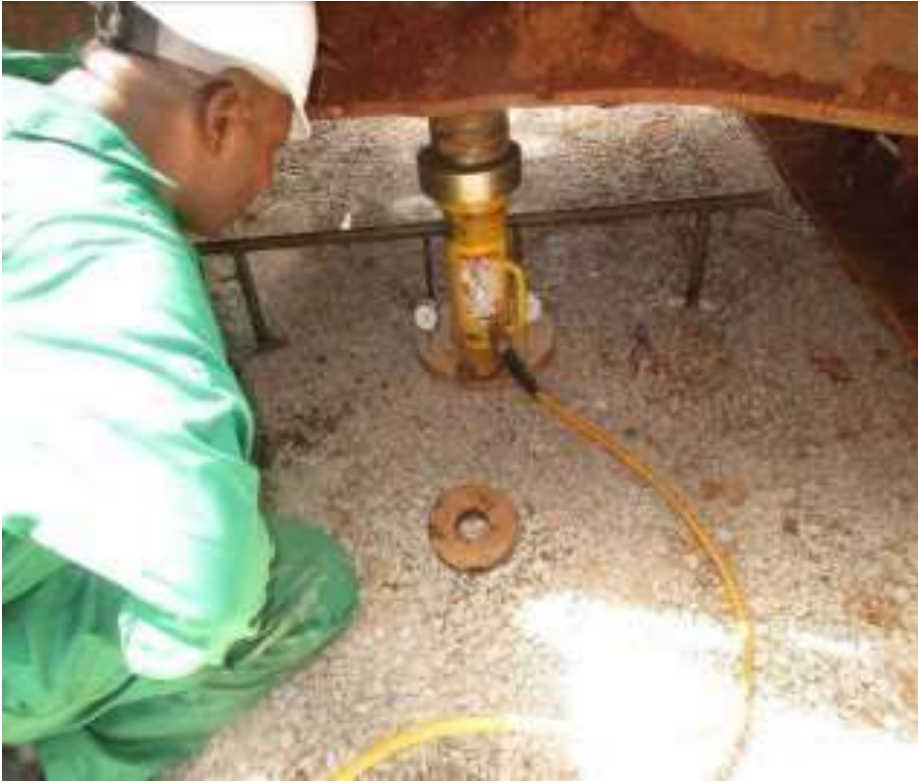
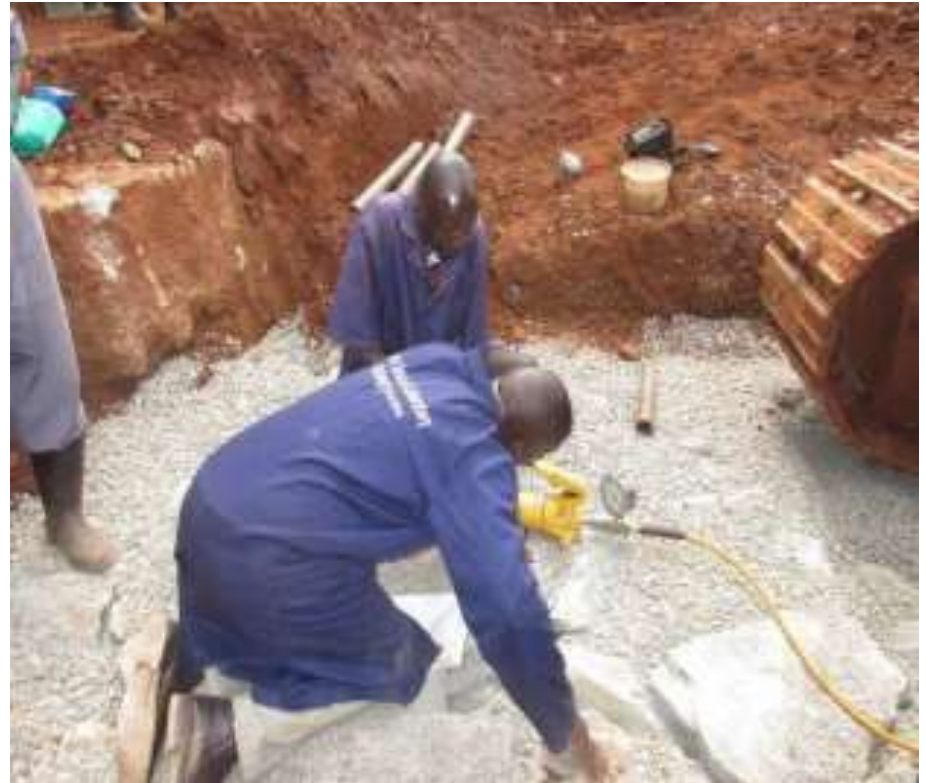
Plates 4&5: Taking the dial gauge readings after applying the loads

The corresponding settlement values for every applied live load are recorded from the dial gauge to 0.01mm degree of accuracy. Observations on the load increments not less than 5kN are taken until the rate of settlement was beyond the dial gauge reading for at least five minutes each time. The same process was done on the other location investigated.

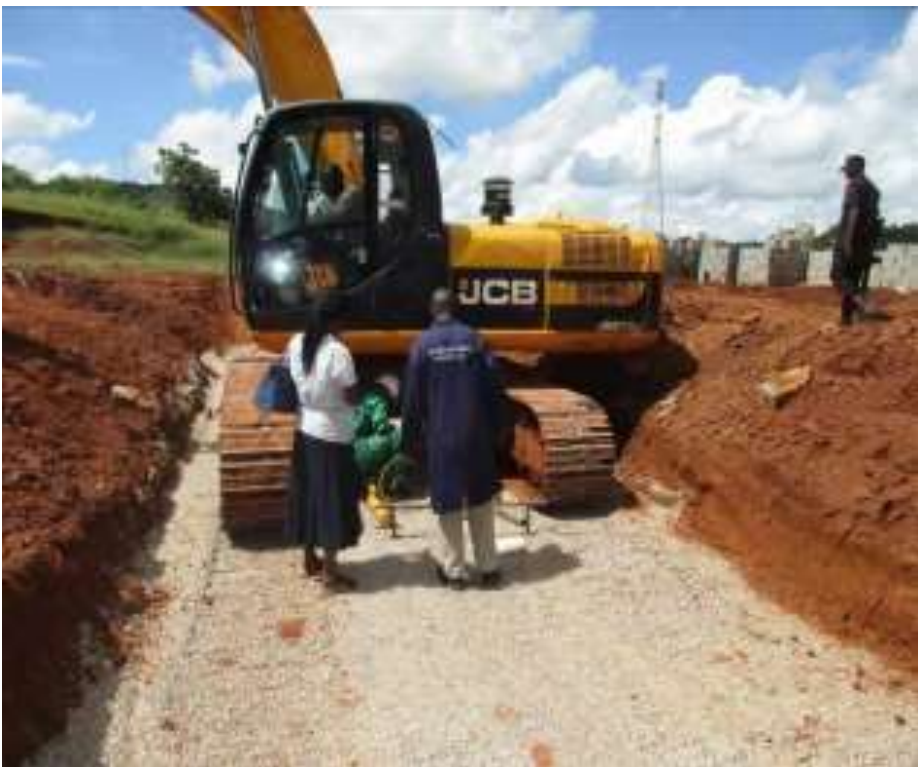
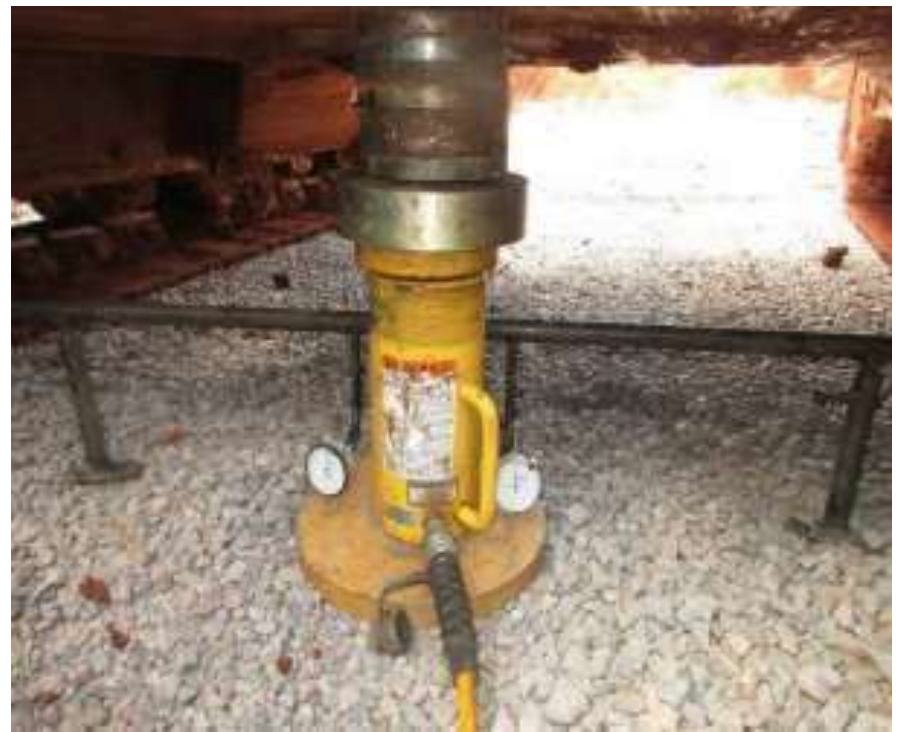
Plates 6&7: A trackcavator providing the necessary live load for the equipment

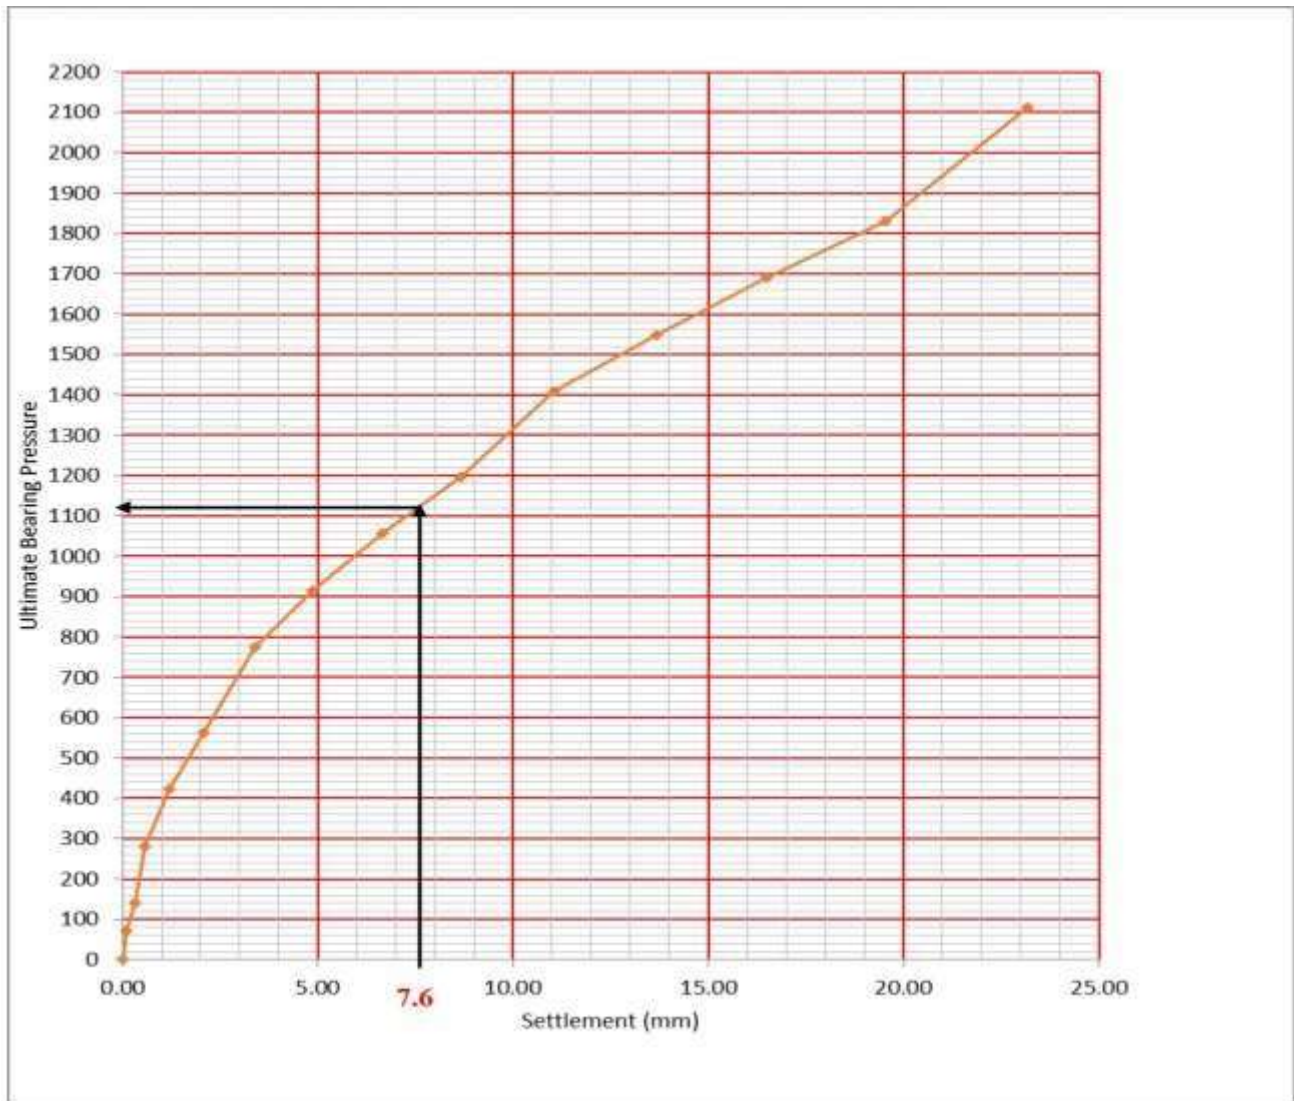
Figure 1.0: Graph of bearing pressure versus settlement for test point 1

APPLIED LOAD (KN)	BEARING PRESSURE (kN/m²)	AVERAGE SETTLEMENT (mm)	CUMMULATIVE SETTLEMENT (mm)
0	0	0.00	0.00
5	70	0.12	0.12
10	141	0.20	0.32
20	282	0.28	0.59
30	423	0.63	1.22
40	563	0.88	2.09
55	775	1.31	3.40
65	915	1.48	4.87
75	1056	1.78	6.65
85	1197	2.00	8.65
100	1408	2.41	11.06
110	1549	2.63	13.69
120	1690	2.83	16.51
130	1831	3.05	19.56
150	2113	3.63	23.19

Test point	Width of foundation m	Size of plate mm	Observed settlement mm	Ultimate bearing capacity Pa	Allowable bearing capacity Pa
TP1	3.0	300	7.6	1220	406.7
TP2	3.0	300	7.6	1280	426.7

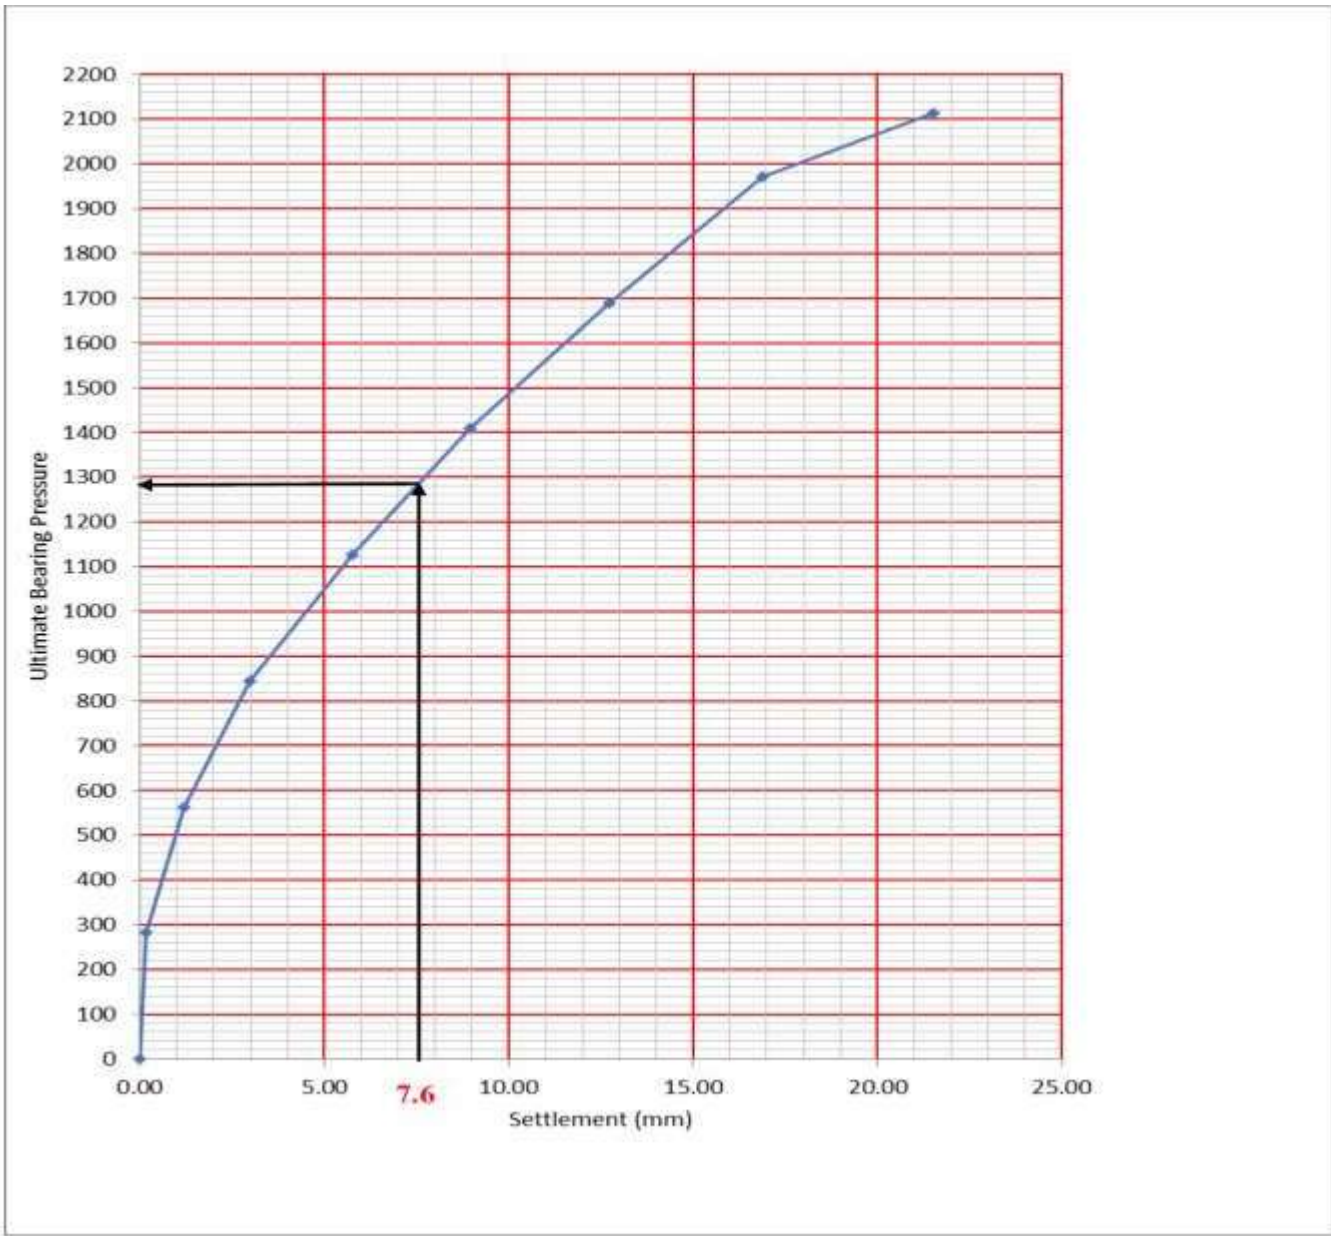
Figure 2.0: Graph of bearing pressure versus settlement for test point 2

APPLIED LOAD (KN)	BEARING PRESSURE (kN/m²)	AVERAGE SETTLEMENT (mm)	CUMMULATIVE SETTLEMENT (mm)
0	0	0.00	0.00
20	282	0.16	0.16
40	563	1.02	1.18
60	845	1.81	2.99
80	1127	2.78	5.77
100	1408	3.20	8.97
120	1690	3.75	12.72
140	1972	4.16	16.88
150	2113	4.63	21.50

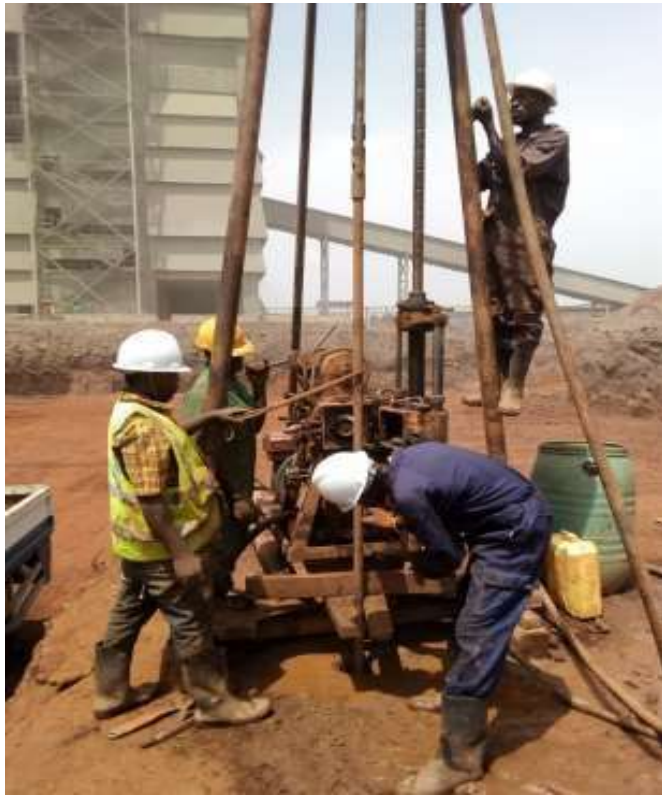
Geotechnical Drilling at Tororo Cement Factory

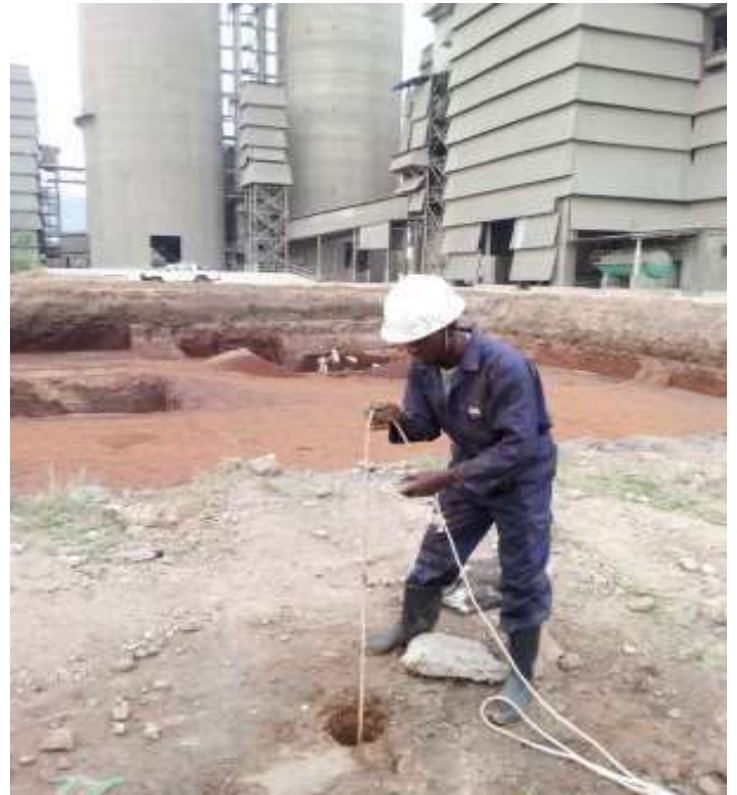
Taking the level of water table for a drilling site at Tororo Cement Factory

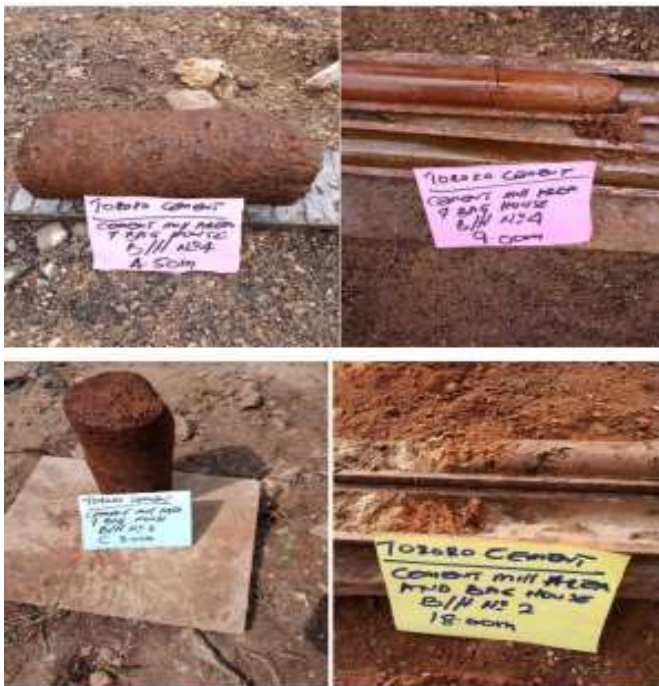
Materials samples extracted for further laboratory testing and analysis
